# **The Impact Response of Carbon/Epoxy Laminates**

(MSFC Center Director's Discretionary Fund Final Report,  
Project No. 94-13)

*A.T. Nettles and A.J. Hodge*

*Marshall Space Flight Center, Marshall Space Flight Center, Alabama*

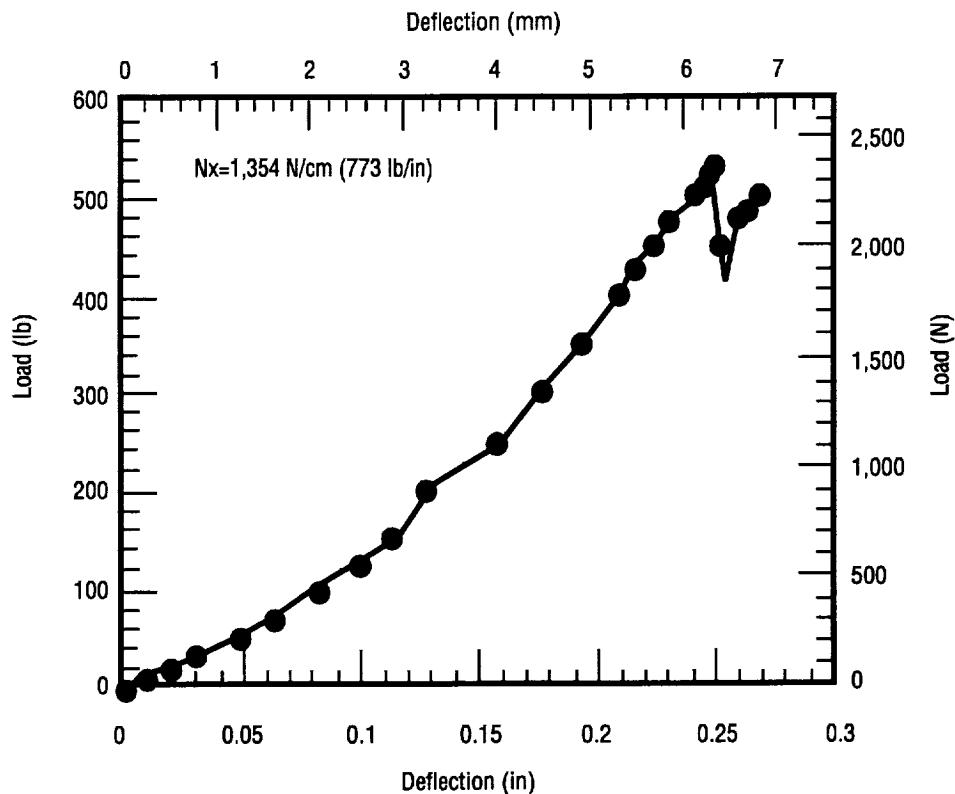
Two specimens were prestrained and statically loaded until they could no longer hold a load. Only load-deflection data were generated from these tests. The results are shown in figures 52 and 53.

Figure 52. Load displacement from a statically loaded specimen (loaded until failure).

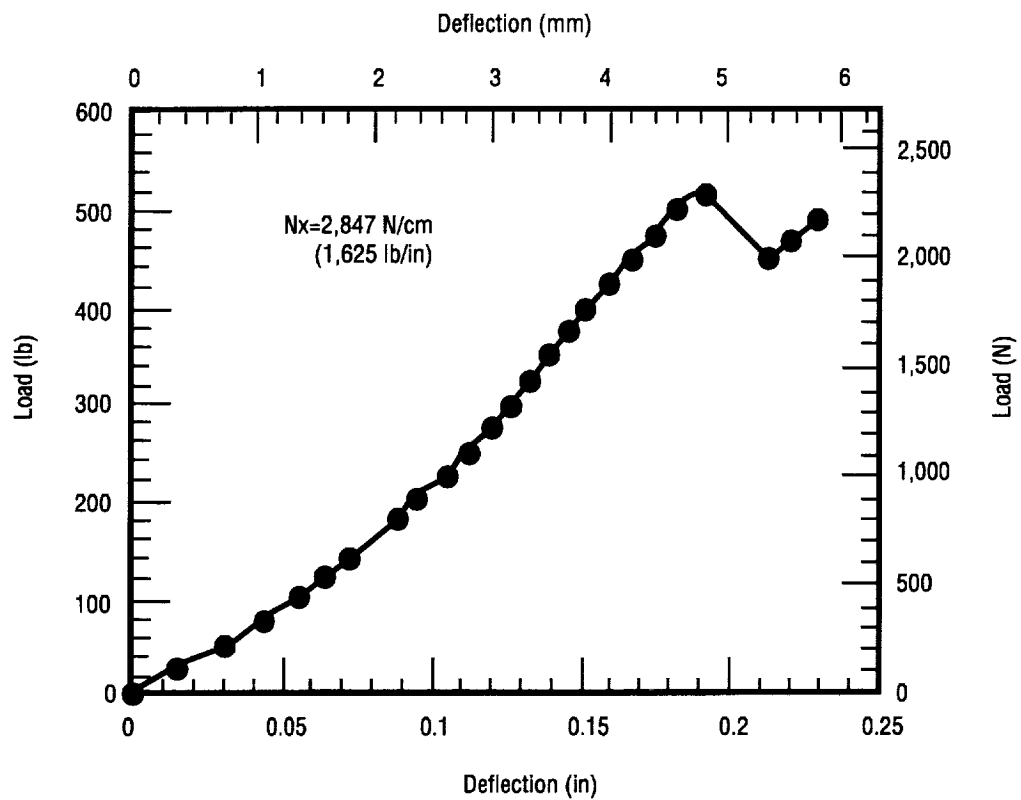
Figure 53. Load displacement from a statically loaded specimen (loaded until failure).

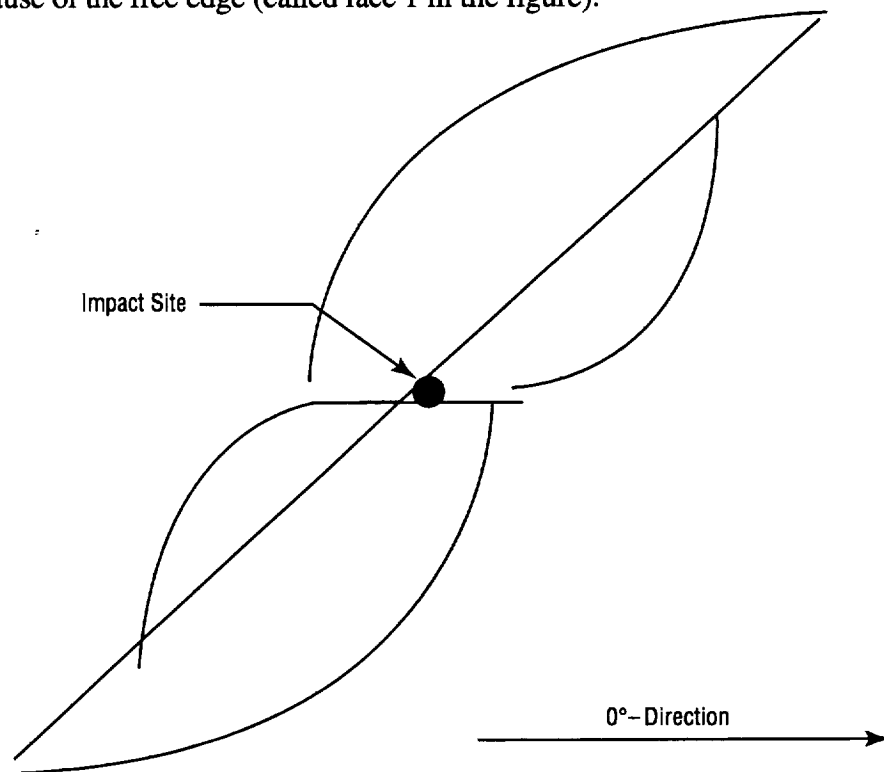
The initial damage consisted of a matrix crack in the bottom +45° ply with delaminations forming as shown in figure 54. On either side of the impact site, the delaminations consisted of two zones, one usually smaller than the other. As a matrix crack develops in the bottom +45° ply, a free edge is created and the stresses must redistribute themselves so that equilibrium is maintained. This “free edge effect” is the same mechanism outlined by Pipes and Pagano.<sup>126</sup> Figure 55 shows schematically how the geometry of the problem influences the delamination growth, mainly due to the transverse interlaminar stress,  $\sigma_z$ , that is set up because of the free edge (called face 1 in the figure).

Figure 54. Schematic of bottom ply splitting and associated delaminations.

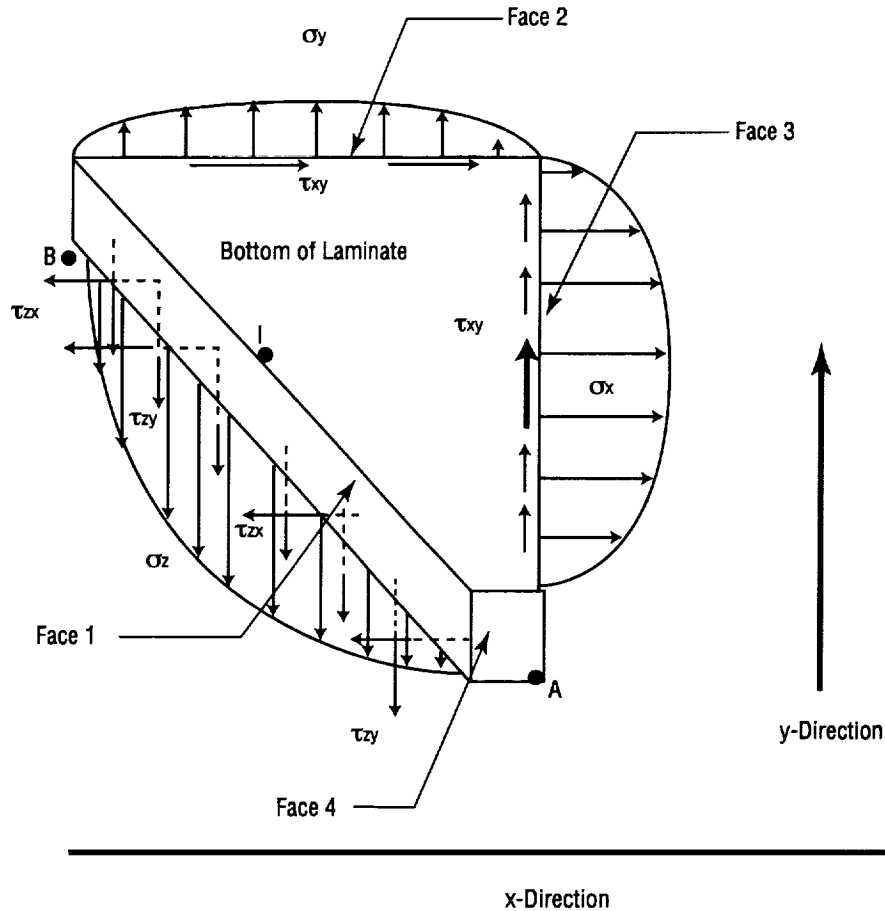
Figure 55. Stresses associated with back face matrix crack.

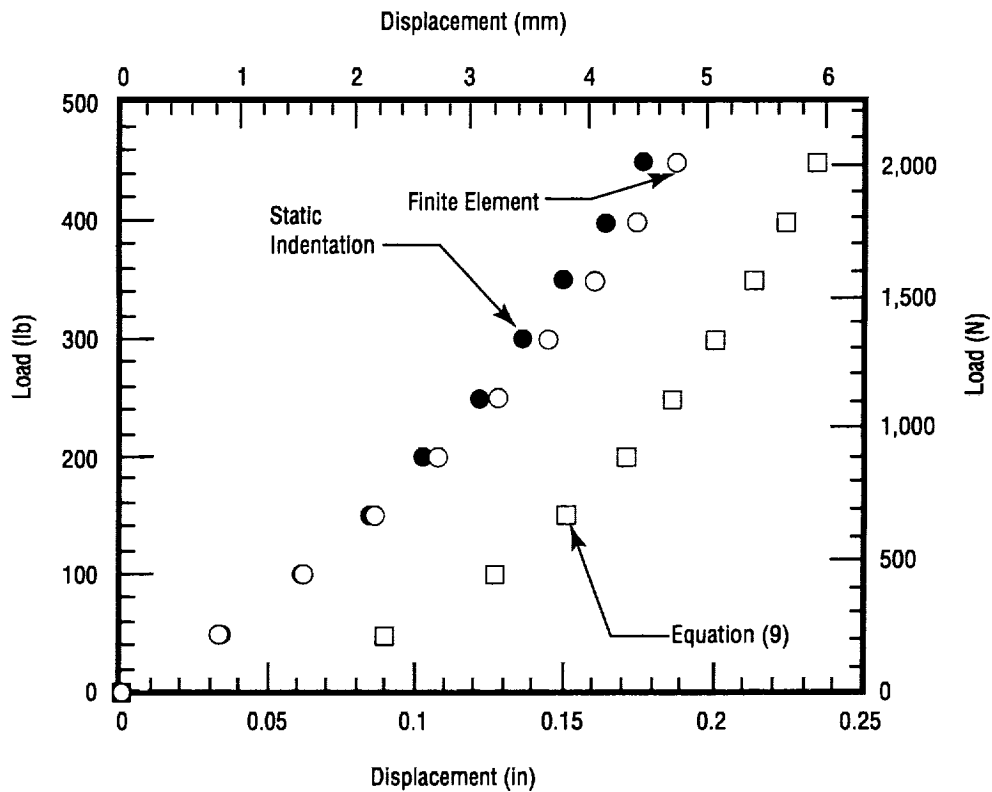
Figure 56. Load-deflection data comparison between equation (9), the finite element method, and static indentation data for a prestrain of  $4,000 \mu\epsilon$ .

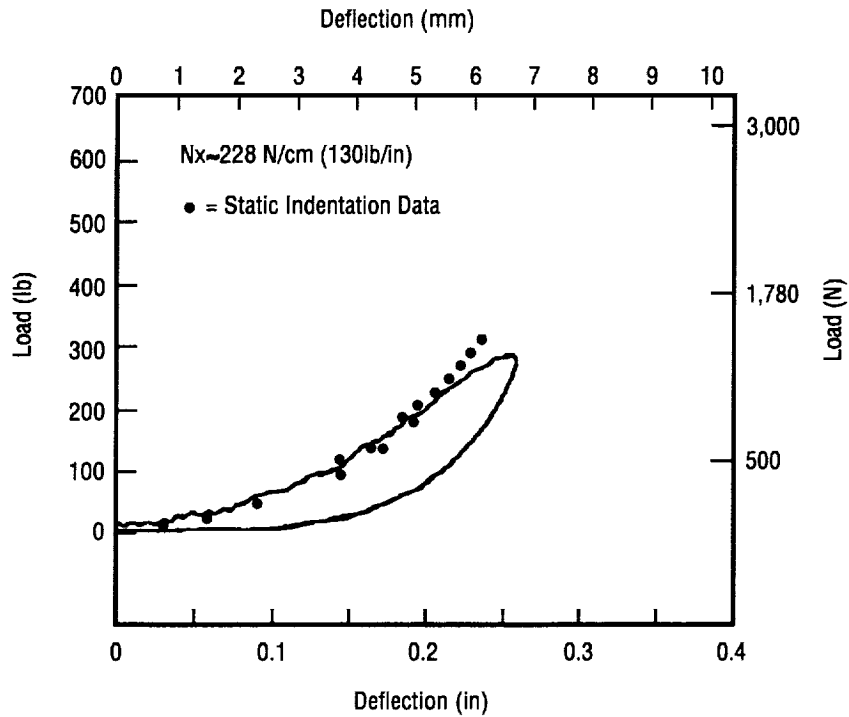
Figures 58–60 show load-deflection data for three different levels of preload for both the static indentation and impact tests. These data are seen to match fairly well, especially at the lower end of transverse deflection and at lower preloads. The static indentation data show a larger load for a given deflection at the higher end of deflection. Note that the data from the impact tests show a small drop in stiffness along the load-deflection curve whereas this drop is not seen in the data from the static indentation tests. In addition, figure 59, which has static indentation data for a specimen with heavy damage, shows that the static indentation specimens can sustain a slightly higher load before the first sudden drop in load is observed. In figure 60, no damage has occurred on the static indentation specimen at 1,780 N (400 lb), but obvious damage has occurred in the impacted specimen.

Figure 58. Comparison of load-deflection curves for a static indentation specimen and an impact specimen both preloaded at  $\approx 228 \text{ N/cm (130 lb/in)}$ .

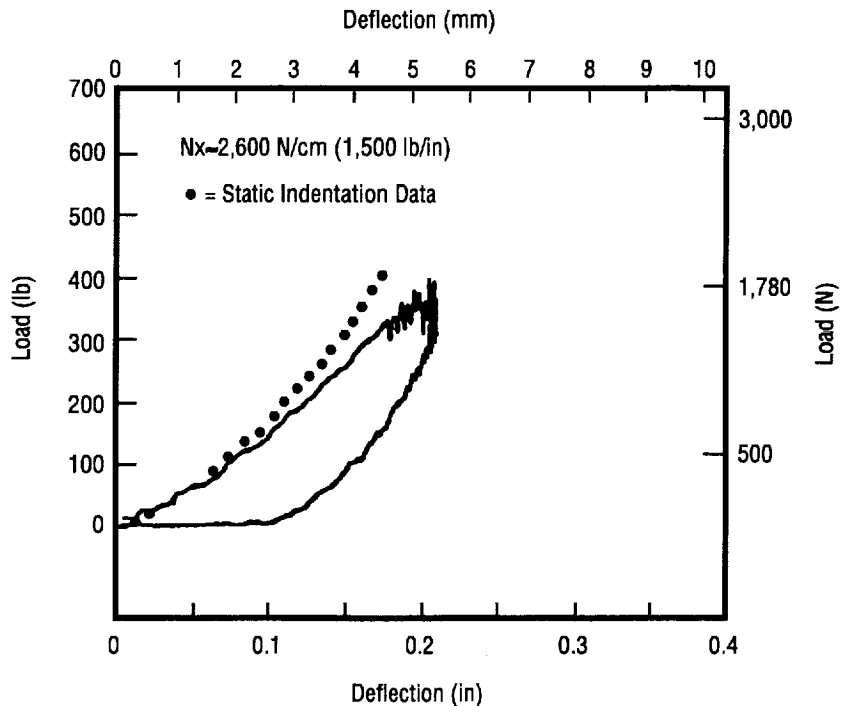
Figure 60. Comparison of load-deflection curves for a static indentation specimen and an impact specimen both preloaded at  $\sim 2,600$  N/cm (1,500 lb/in).
